# **Safety of Breakwater Armour Layers with Special Focus on Monolayer Armour Units**

## **(Discussion Based Upon Four Decades Experience of Breakwater Damage)**

**Ole Juul Jensen** Director, Marine and Coastal Engineering,  
COWI A/S, Denmark (From 1975 to 1994, Danish Hydraulic Institute)

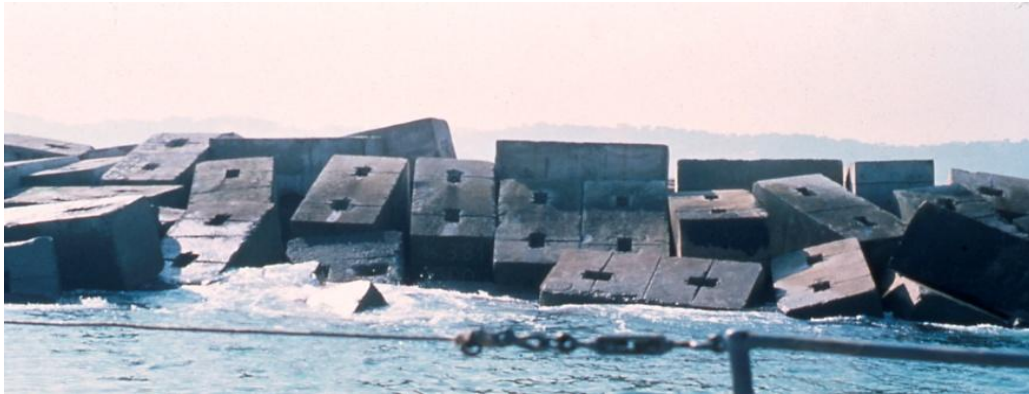
Figure 1 Example of breakwater built in the 1930'ies and armoured with large rectangular blocks.

Designers of breakwaters have since the 1930'ies relied upon an estimation of waves at the site and the use of empirical formulae for the determination of the size of armour units. In many cases it was also on a "trial and error" process, where the breakwater was designed based upon limited knowledge about the wave conditions, which in many cases resulted in a too weak design. The breakwater was then repaired after damage and hence it became stronger and stronger. Some of the earlier breakwaters with artificial units were armoured with cubes or rectangular blocks and as for rock breakwaters; the repair is often relatively easy, as it can be done by adding more armour units for reinforcement and strengthening. One example of such blocks from 1930'ies is shown in Figure 1.

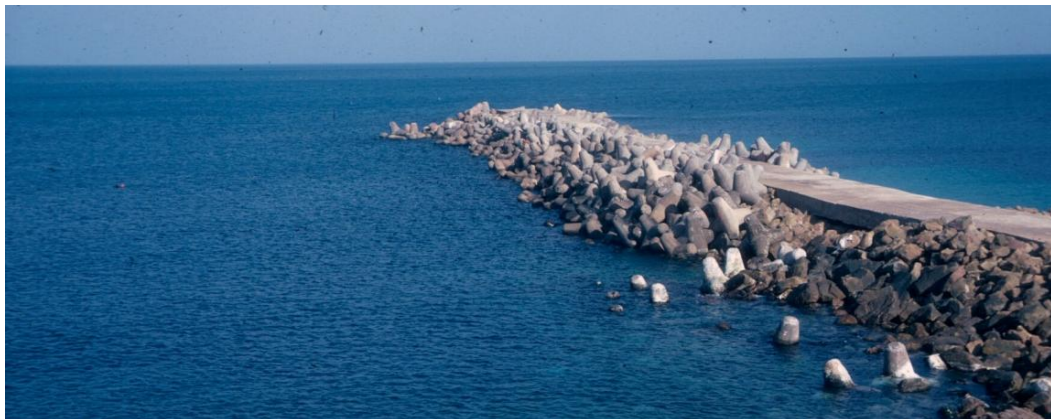
Figure 2 Damaged tetrapod breakwater in El Kala, Algeria.

In the 1950'ies the use of the new armour unit, Tetrapod, took off and many successful projects were implemented. However, breakwater damage occurred for also with Tetrapods. An example from around 1979 is shown in Figure 2.

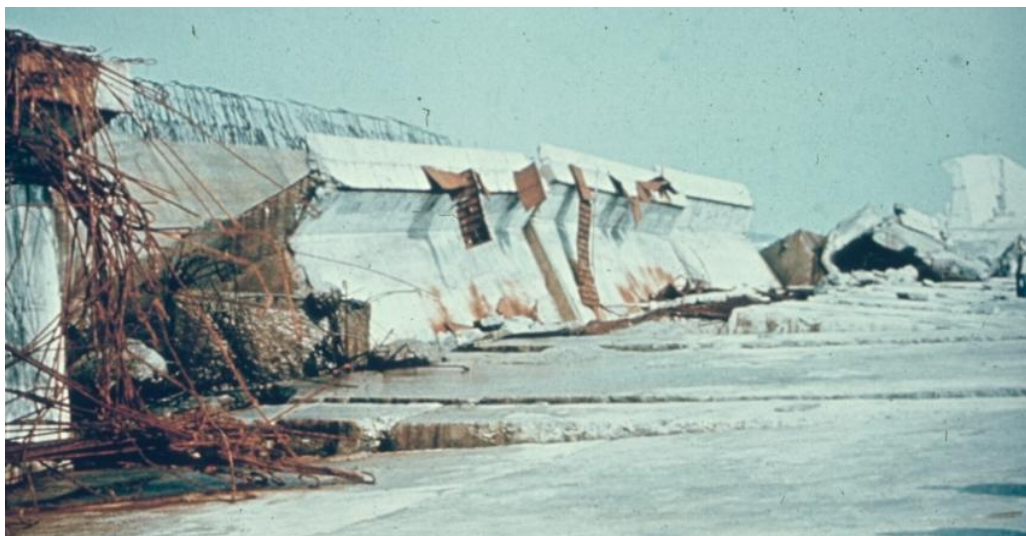
Figure 4 Sines breakwater failure seen from behind the superstructure.

The Sines failure attracted a lot of attention in the coastal engineering profession and many papers and studies have been made to explain and document what went wrong. The breakwater was built with 42t Dolos on a slope of 1:1.5 and the design wave condition was:  $H_s=11\text{m}$  with  $T_p=16\text{s}$ . This corresponds to a stability coefficient of  $K_D=23.6$ . The severe damage occurred in a storm with  $H_s=9\text{m}$  and  $T_p=19\text{s}$  (corresponding to  $K_D=13$ ). Dolos was a non-patented armour unit and not reinforced. In addition the first Dolos had a quite slender waist ratio, that was later increased. The Dolosse used in Sines were about twice as big as any other units used until 1976, where the breakwater was designed. In hindsight, this was a very daring design and nature proved to the coastal engineering profession that there was a limit to the use of slender Dolosse in the harsh wave climate of the Atlantic. For the Sines breakwater as for other Dolos armoured breakwaters that failed, the limited concrete strength of the large Dolos had not been taken into account in the design. It also became clear that the construction process in reality gives a quite loose packing density and that for so high stability coefficients the Dolosse are rocking under heavy wave attack. This led to substantial breaking of the armour units and compaction of the armour layer, especially below SWL and eventually resulted in total failure of the breakwater. It was proven, as also proven by other breakwater failures and damages that so large concrete armour units are too fragile and brittle and will break under wave loading and the armour layer settlements that happen due to the loose packing density.

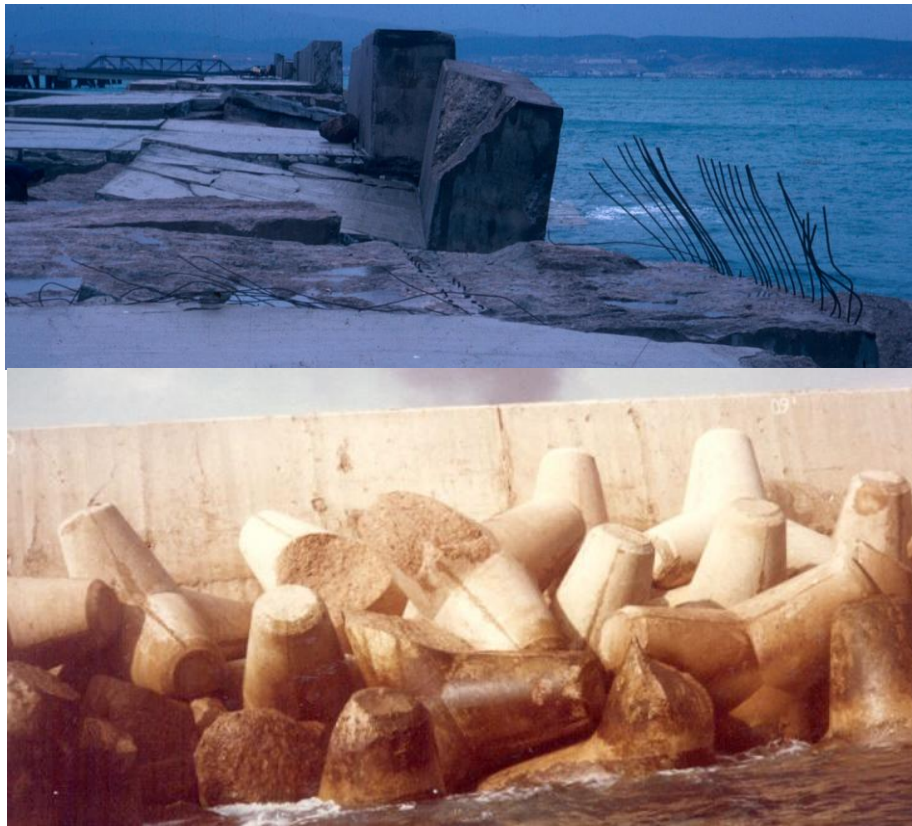
Figure 6 Photos of Arzew el Djedid breakwater damage. Above, most damaged sections and below, section with settlement of entire armour layer and broken units.

Figure 6. Although the breakwater is in the same water depth for its entire length and should be exposed to almost the same wave impact, the damage was varying along the breakwater trunk and also the roundheads were severely damaged. The total displacement of the armour layer in many sections lead to undermining of the very heavy and 4m thick superstructure, which was also heavily damaged, see Figure 6. Subsequent model test investigations showed that the breakwater armour layer must have been constructed with a relatively high porosity and loose packing density and that the wave impact during the storm led to compaction and settlements of the entire armour layer, see (Abdelbaki & Jensen, 1983). This must have led to the breakage of the units and hence the loss of interlocking and failure of sections of the armour layer. For  $H_s=7\text{m}$ , the corresponding  $K_D$  is as low as 5.5; so this would be regarded as safe at the design stage. It is interesting to compare with the breakwater in Figure 2, where some of the  $4\text{m}^3$  Tetrapods had rolled shoreward over the rock armour without breaking, while most of the  $10\text{m}^3$  units broke after having been exposed to the same rolling.

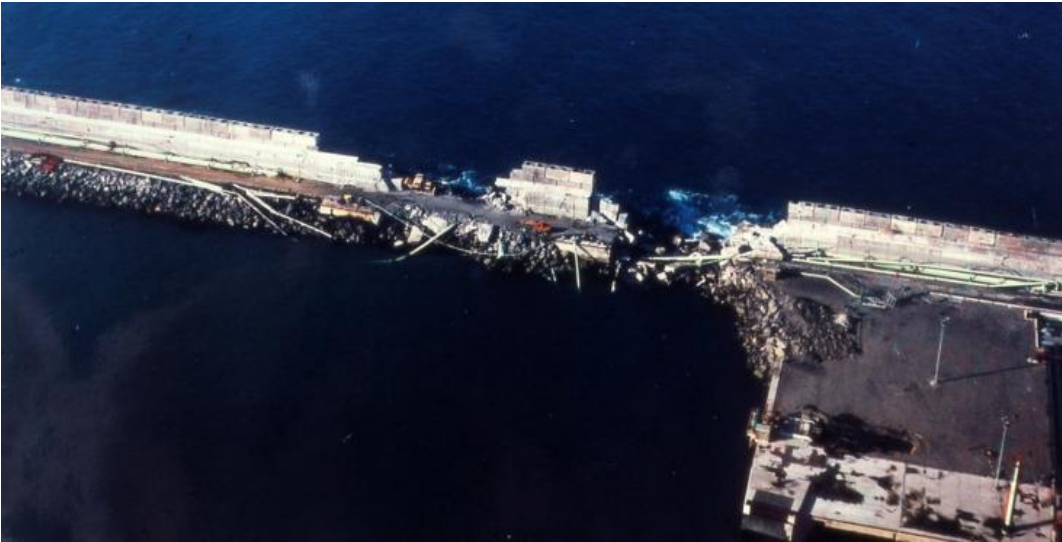
Spain, the author got heavily involved in finding repair solutions.. This breakwater had an armour layer of 82t rectangular blocks on a slope of 1:1.5. The armour layer itself was not sufficiently stable, but damage to the rock toe at level -10 m also contributed significantly to the severe damage to the armour. Figure 7 shows the profile of the damaged breakwater and a photo of the severe damage as seen from the port side. The toe at level -10m had 6-9 t rock and no horizontal berm. It appears in the photo how the breakwater failed and a total breach in the breakwater developed, also cutting the pipelines from the berth for super tankers to the nearby refinery. The damage interrupted the supply of crude oil by super tankers to northern Spain for some months and had serious economic implications both with respect to the costs for repairing the breakwater and the consequential damage and associated costs due to effected operation of the oil terminal. Long series of physical model tests were carried out at DHI to study the reason for the failure (Jensen, 1984). The test runs for different wave heights ranging from  $H_s = 7$  to 11m were repeated a number of times for each wave height, and quite a high scatter was present. The model also showed that for larger waves,  $H_s = 10$  m, the armour layer failed in an unusual mode, where the toe got damaged and the entire armour layer slid down the front face of the breakwater during the action of single large wave.

Figure 7 Bilbao breakwater cross section and photo of damage from the port side.

Long and detailed studies followed and the breakwater was repaired using the same type of armour units, large rectangular blocks, but larger than before and on a flatter slope of 1:2. Furthermore, a proper berm was introduced at a lower level and finally the superstructure was made heavier and it projected less above the armour and would thus be less exposed to large wave impacts, see (Jensen, 1984) for further details of these studies. Figure 8 is a present Google Earth photo of the armour layer in front of the largest oil berth. The armour layer looks intact but possibly with a few spots where blocks might have been displaced.

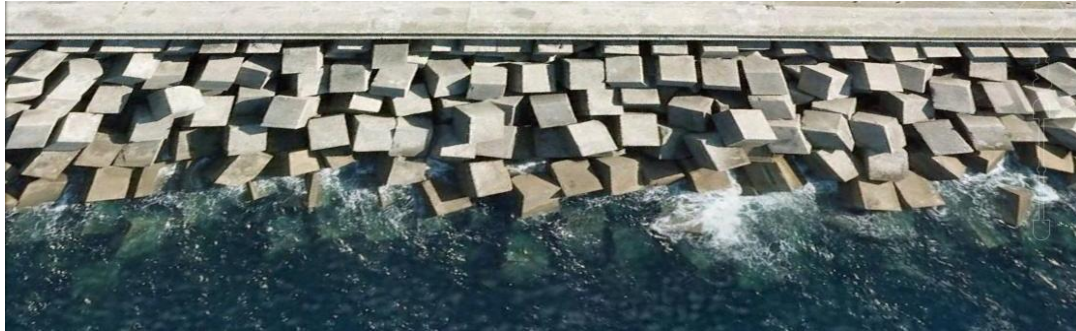
Figure 8 The armour layer on the Bilbao Breakwater 2013 (Google Earth).

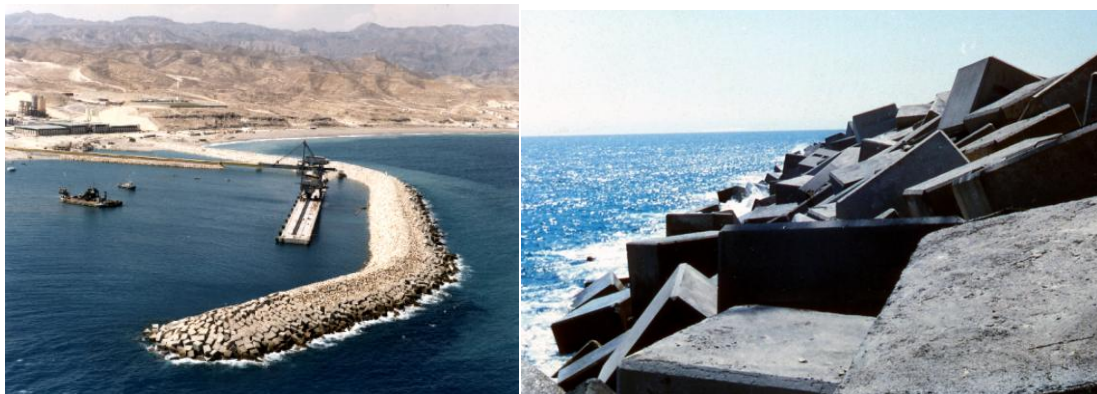
Figure 9 Puerto de Carboneras Breakwater. Cross section in deep water and photos of the port and armour layer.

In 1981 after some of the major failures described in this paper had become common knowledge to the profession, the author got involved in the studies for a new port in Spain, Puerto de Carboneras. The breakwater protects a berth for the import of coal for the power plant seen to the left on the photo in Figure 9. At that time it was clear that there was doubt about the use of both Dolos and Tetrapods for such major breakwaters. The design wave height was about the same as for the Arzew el Djedid in Algeria on the other side of the Western Mediterranean. The author, the team at DHI and the designer, Christiani and Nielsen – Copenhagen developed a new concept shown in Figure 9.

First, it was clear that the breakwater had to be separated from the traffic and the conveyor belt from the berth. Therefore, contrary to other breakwaters nearby, the breakwater was developed as a pure rubble mound structure without a superstructure. As rock could be quarried in the mountains nearby, it was relatively cheap, but the size which could be obtained in large quantities was limited to 2-4 t. Therefore the crest of the breakwater on the major deep water section was made in such high level of +13.5m, that 2-4 t rock could be used on the crest and rear side of the breakwater. Model tests proved

that the transition from the main armour of 58t rectangular blocks to the rock could take place at level +10m. There are two berms on the breakwater, the upper with 2-4 t rock and the lower outer/lower placed directly onto the sand sea bed with 0.2-2 t rock. The outer berm/toe is allowed to sink into the bed and form a solid foundation for the upper berm that has a 2m thick layer of quarry run underneath. The relatively small stones of 0.2-2 t were also used as filter under the 58t armour units. Model tests in 2D and 3D were used for design verification and to the authors knowledge the breakwater has now been in successful service for 30 years. This is verified by the Google Earth pictures available on the Internet.

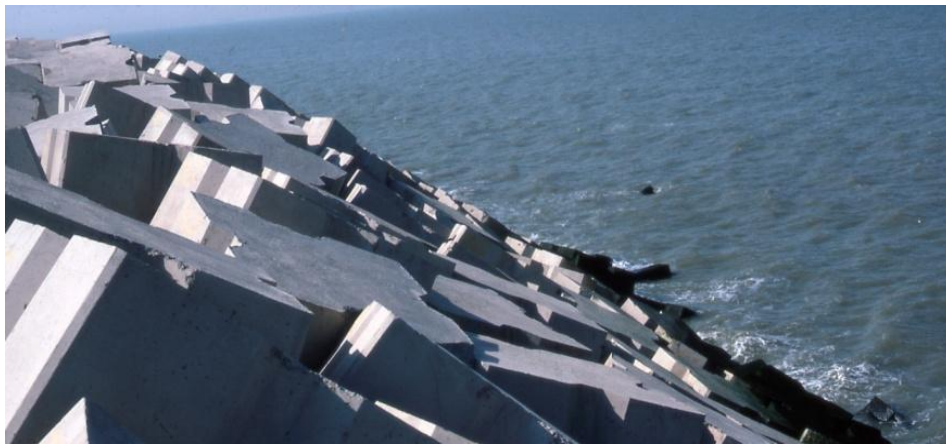
Figure 10 Antifer Cubes in the Port of Zeebrugge.

In connection with the development of Port d'Antifer in Normandy, France, a new armour unit was developed in 1973, The Antifer Cube. It is a tapered cube with grooves tapered the other way, so they could easily be cast in forms without bottom and top and easily taken out of the formwork. These blocks are robust, but there is an apparent tendency that they reorient themselves in the armour layer and form a "pavement" that is relatively smooth for wave run-up. This does not happen so easily for rectangular blocks for example with relative dimensions 1 x 1 x 1.33. When placed randomly the armour layer becomes more rough (see Figure 9) which reduces run up. Figure 10 is from Port of Zeebrugge in Belgium, where Antifer Cubes were successfully used. In comparison with Figure 9, the outer surface of the armour layer appears more smooth.

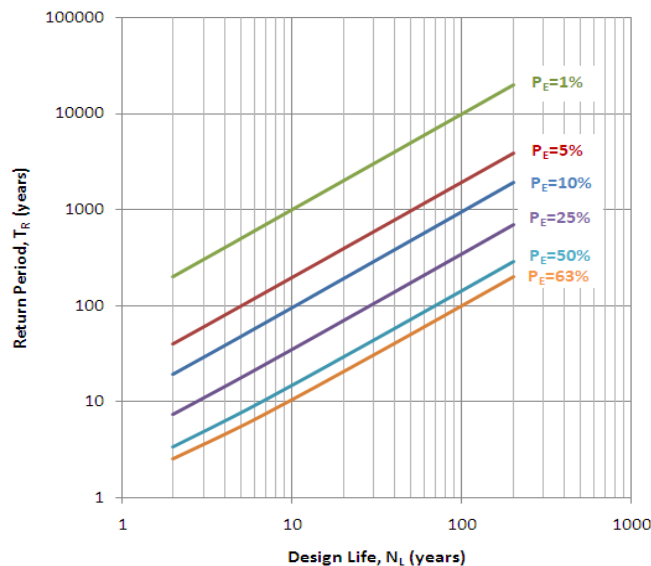
Figure 11 Relation between design life, return period and encounter probability.

The encounter probability ( $P_E$ ), i.e. the probability that the design sea state is occurring during the structural lifetime,  $N_L$ , should rather be used in assessing a breakwater design instead of a selected return period,  $T_R$ , as it also includes the probability for exceedance of the design event within the defined structural lifetime of a project (Burcharth, *The Lessons from Recent Breakwater Failures, Development in Breakwater Design*, 1987).

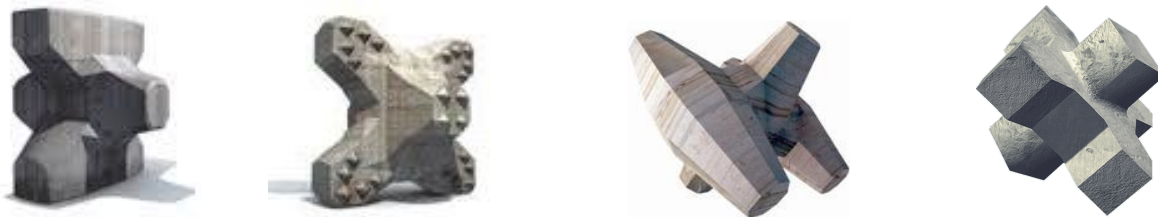
Figure 12 Comparison of monolayer breakwater armour units: Accropode I, Accropode II, Core-Loc and Xbloc.

Since the introduction of the Accropode as the first monolayer unit in 1981 followed by the other types of monolayer systems, several hundreds of applications have been constructed. Many successful projects have been made, but in some cases problems have occurred. The patentees and promoters claim in their material that  $K_D$  values as high as 15 or 16 applies for mild sea bed slopes (see Figure 12 below), and that model tests shall be carried out for final verification.

<b>COMPARISON OF MONOLAYER ARMOR UNITS</b>					
(data for sea bed slope 1:100)					
		Accropode I	Accropode II	Core-Locs	Xbloc
$K_D$ recommended, trunk	-	15	16	16	16
$K_D$ recommended, roundhead	-	11.5	12.3	13	13
Example $10\text{m}^3$ units	$\text{m}^3$	10	10	10	10
$H_s$ max, for design	m	7.80	7.95	7.95	7.95
Block height	m	3.09	3.25	3.56	3.11
Weight ( $2.4\text{ t/m}^3$ )	t	24	24	24	24
Armour layer thickness	m	2.78	2.93	3.27	3.00
Number of units per unit area	units/ $100\text{m}^2$	13.70	13.40	13.30	12.50
Porosity	%	50.83	54.30	59.41	58.7
Max. number of rows up slope	-	20	20	20	20
Max. size of unit in design table	$\text{m}^3$	28	28	11	20

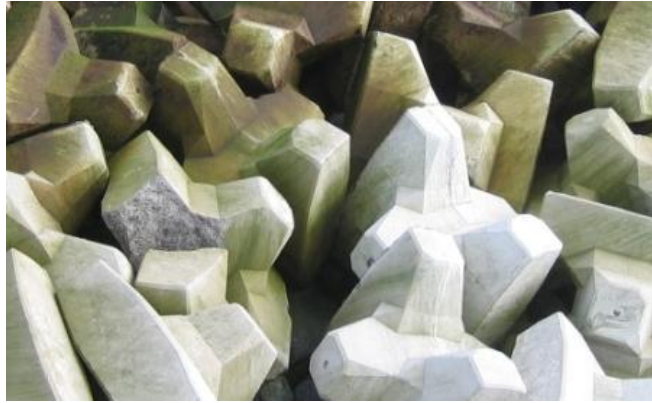
Figure 13 Example 1: Accropode breakwater with approx.  $K_D=15$  after exposure to design event. Note broken units and openings, non-interlocking units.

Also monolayer armoured breakwaters have suffered damage, and it appears that the stability factors and procedures previously used are in some cases not leading to safe and robust designs. It is clear that until now, the damage occurring to these projects is less severe than what was experienced previously in Spain, Portugal and Algeria, and shown in the examples above. But it is however worrying for our profession, that there still today seems to be a fierce competition to minimise the size of armour units. The examples, from nature and practical applications, shown in Figure 13 and 14 are visualising that more safety has to be built into such breakwaters.

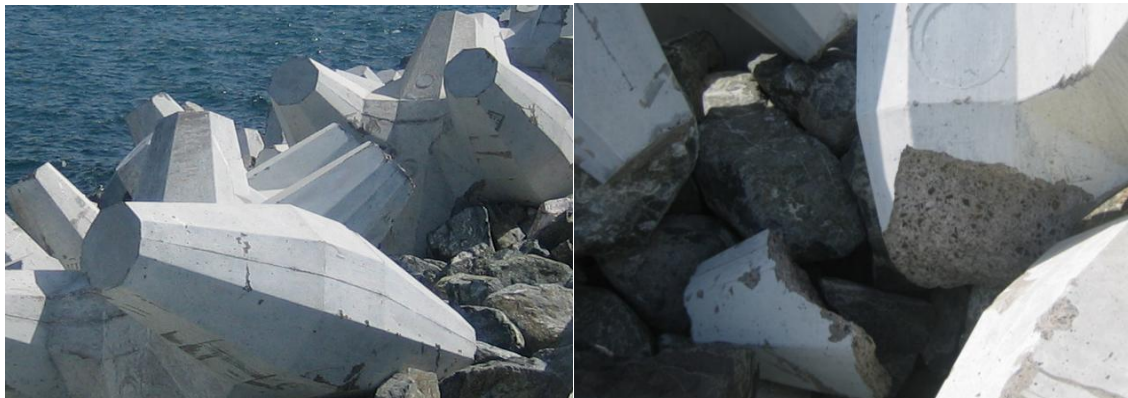
Figure 14 Example 2: Core-Loc breakwater with approx.  $K_D=16$ . Note settlement of entire armour layer creating gap at wave wall and some breakage.
